EVALUATION OF IN-SITU ELECTROSPUN NANOFIBER SCAFFOLDS IN HARD-TO-HEAL WOUNDS

Dr. Charalambos Agathangelou MD, PhD Medical Gerontology, PhD Dermatology and Venerology.
Director at Dhali Community Geriatric, Rehabilitation and Wound Centre, Dhali, Nicosia, CYPRUS

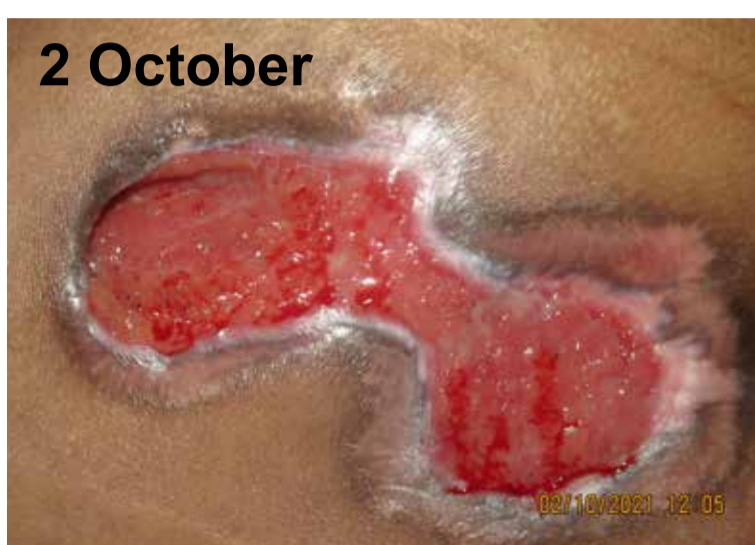
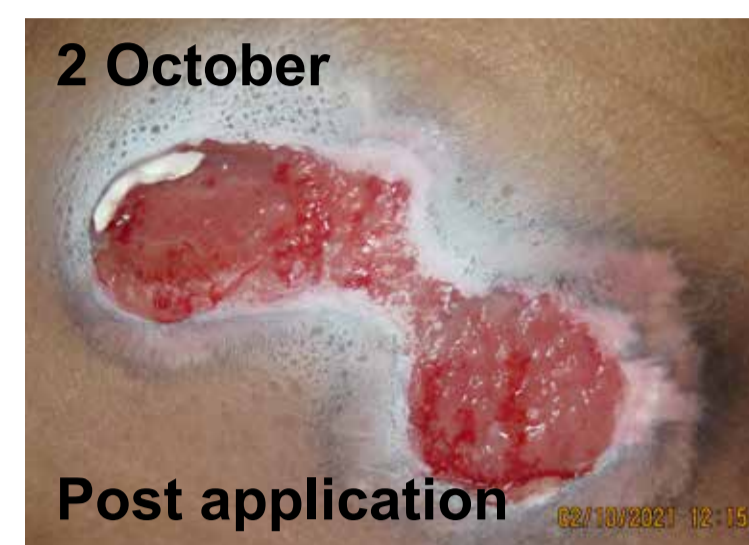
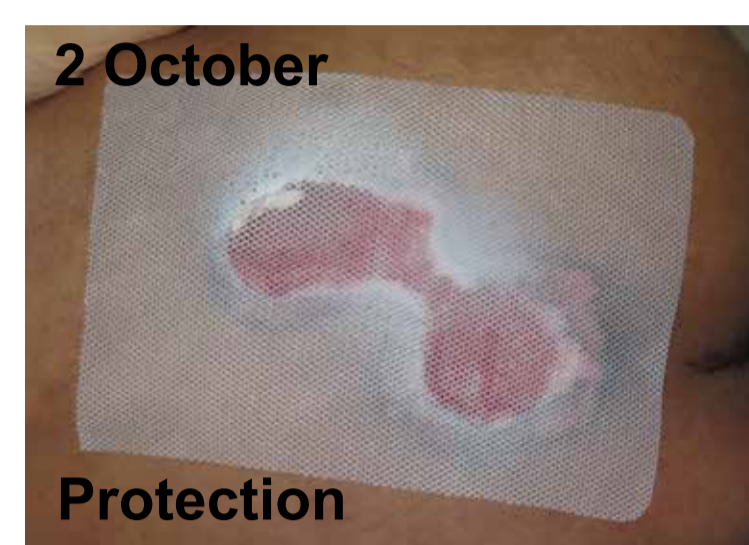
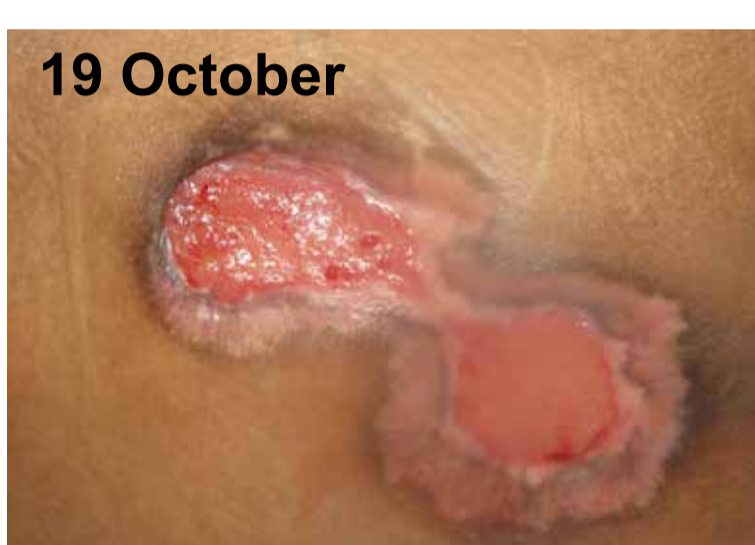
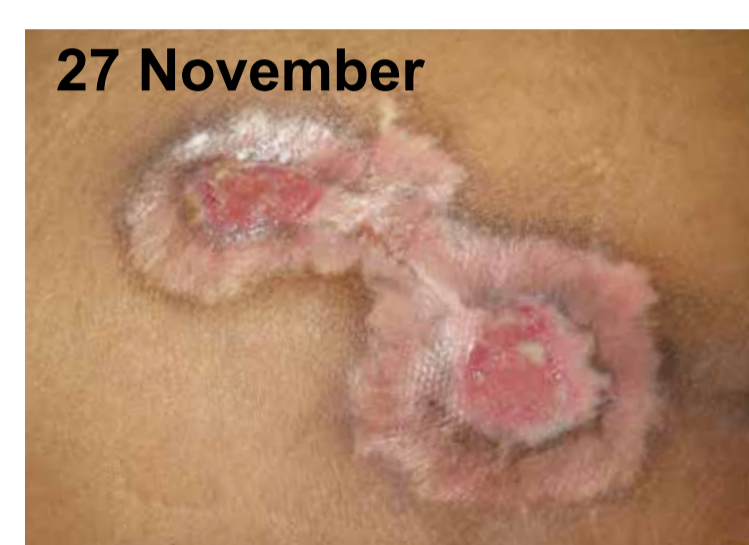
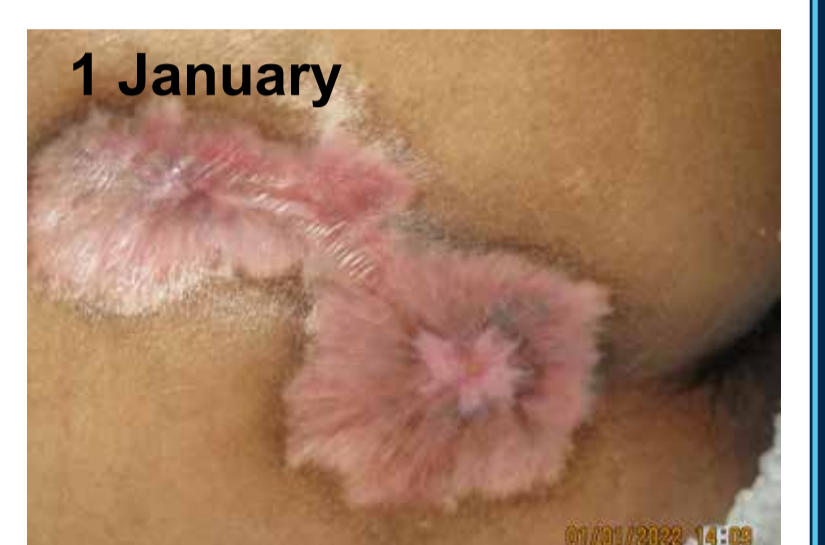
Scaffold applications

30-year-old male, malnourished (in spite of prescribed protein drinks), with a tracheostomy, who has been in the ICU for six months following a traffic accident. During this time, he developed multiple pressure injuries on his sacrum, trochanters, malleolus and heels. Duration of most wounds was 18 months.

2 October
19 October
27 November

Photos on the left show the wound at time of the 2nd and 3rd scaffold application. Photo to the right shows the healed wound.

The pain level dropped to 3 (VAS) after application of the electrospun nanofibrous matrix, so analgesia was no longer needed. After application, the electrospun nanofibrous matrix was covered with a protective non-stick layer as well as a superabsorbent pad, (the pad was to absorb eventual leakage of faeces). We only needed to change the superabsorbent pad on a weekly basis. After 3 weeks the pain level dropped to 0. The 18-month-old wound healed in 3 months.

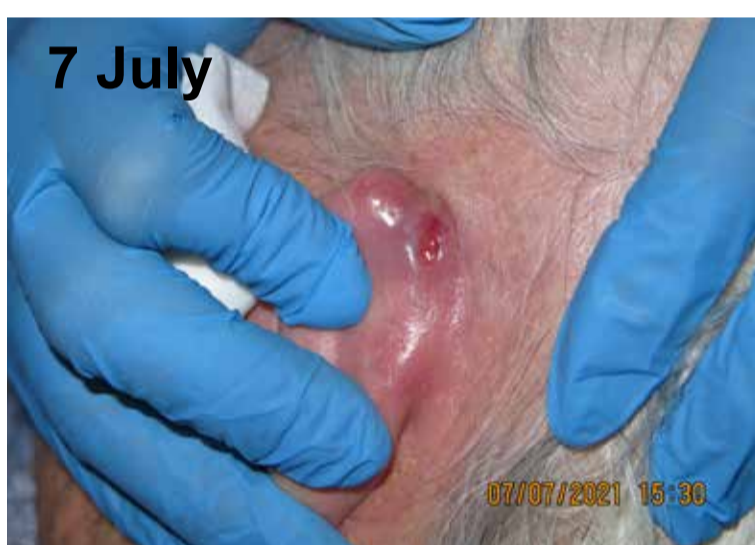
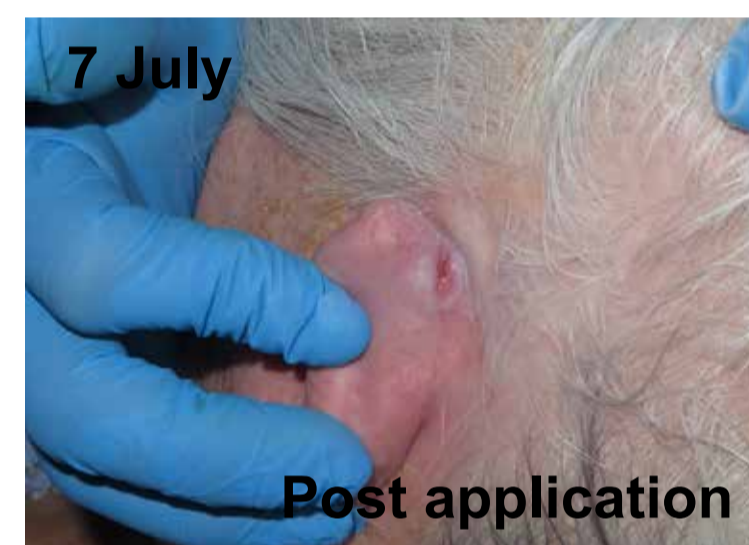
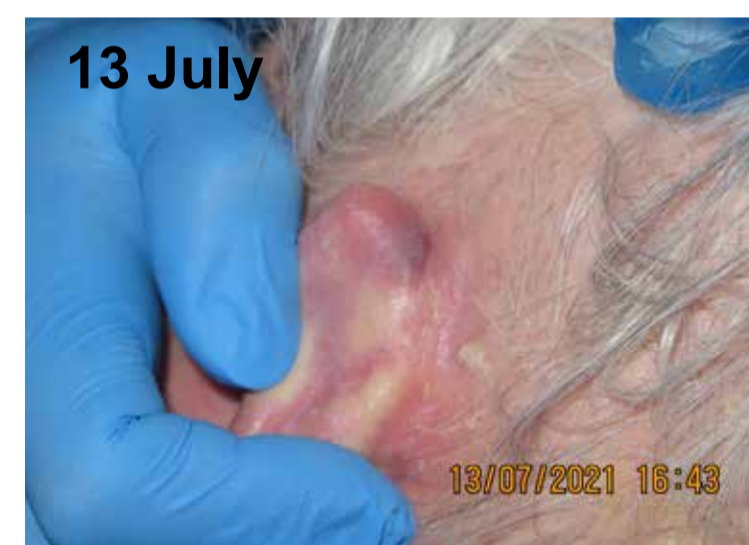
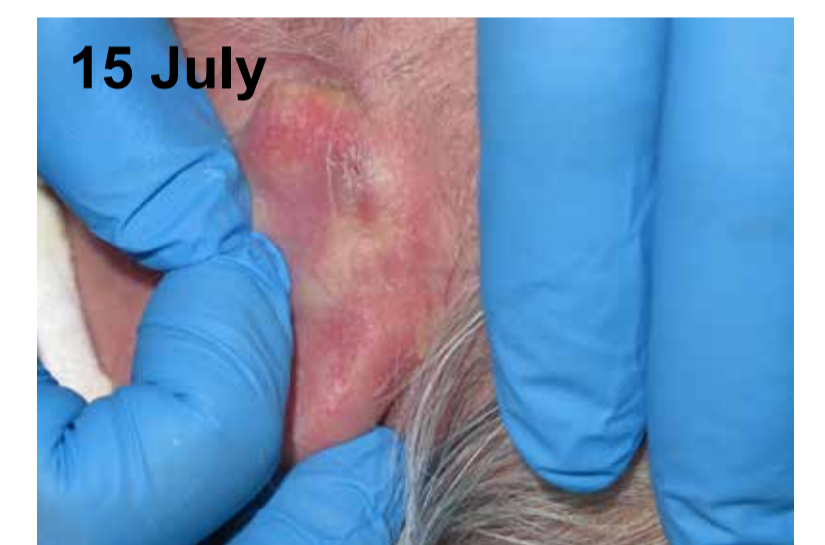
99-year-old female on constant Oxygen flow of 2 liters/minute due to COPD. History of CVAs. Has an NG tube in the last 2 years. Other than that, the patient is alert and verbal. Recurring pressure injuries on the ears due to pressure from the tube. This current pressure injury has been open for six weeks. Previous treatments included hydrogels and hydrocolloids.

Only one application of electrospun nanofibrous matrix was needed, the wound was closed 8 days later. Follow-up six months after healing the wound was still closed showing that the new epithelialization retained its elasticity. Nothing has changed in her condition or care provided.

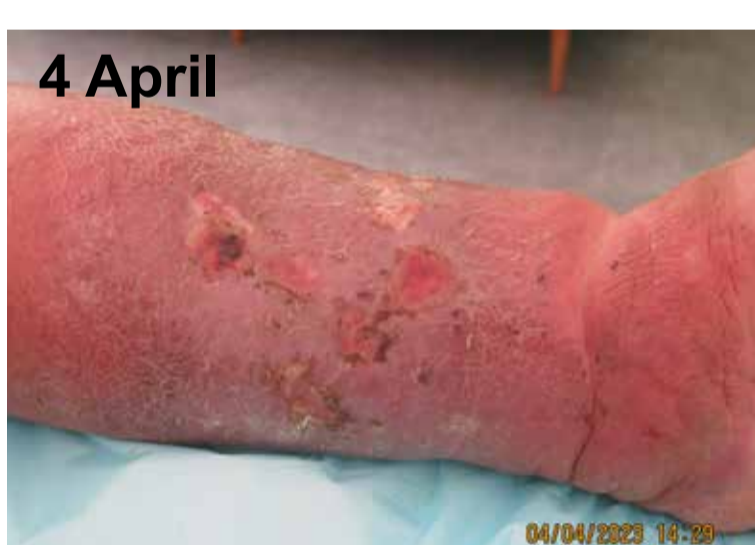
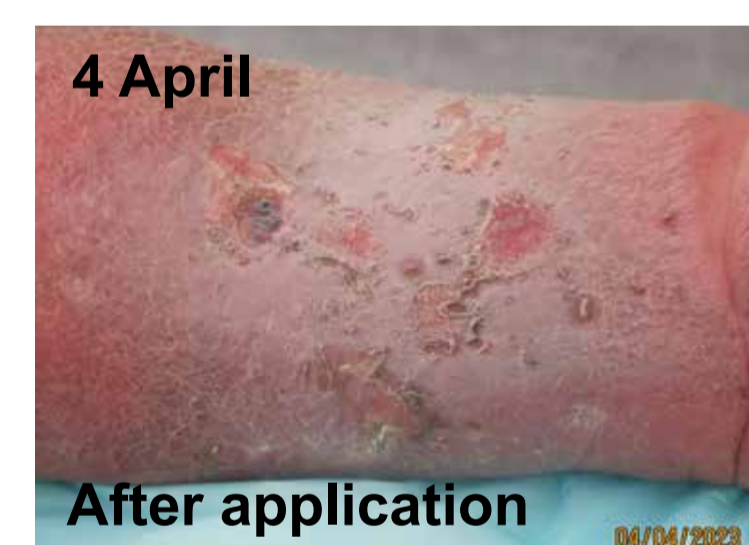
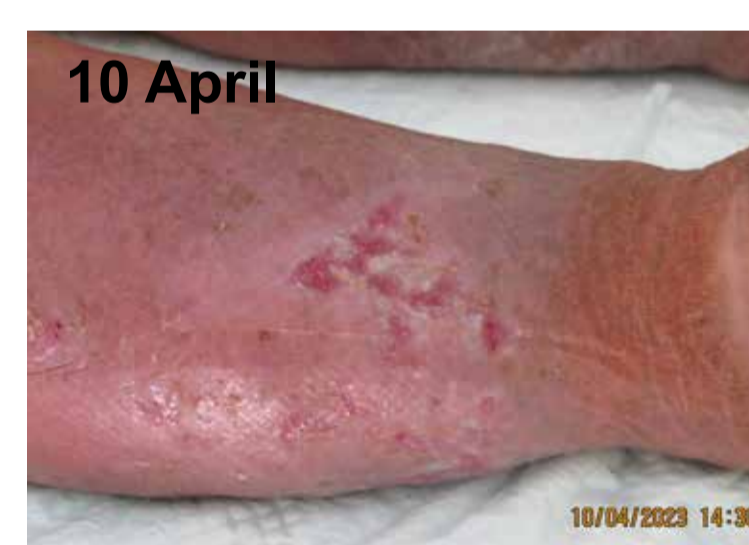
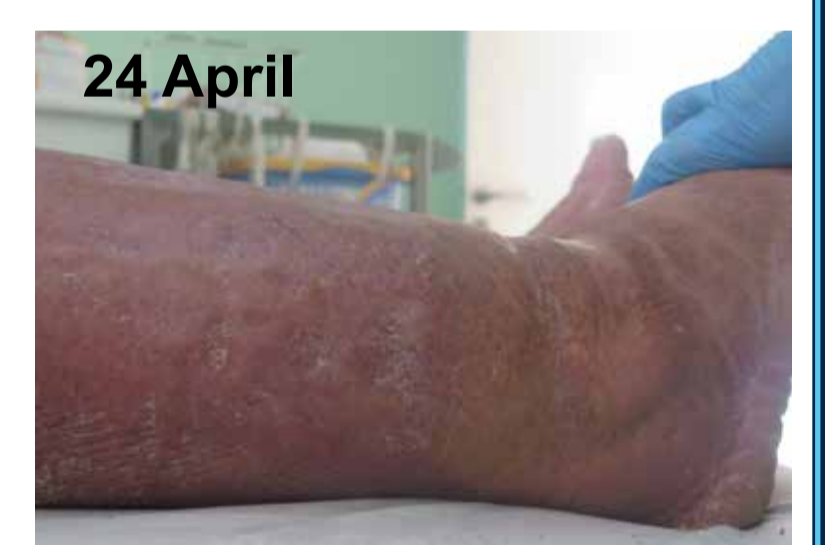
77-year-old male with small (3x3 cm) highly exuding wounds on both legs caused by venous insufficiency and lymphedema. In spite of having received lymphatic drainage and compression three times a week by a lymphedema specialist the wounds were getting worse.

A single treatment with with electrospun nanofiber scaffold was performed on the 23 of March. Due to the high exudation the wounds were covered with a super-absorbent dressing with a built-in wound contact layer that does not adhere to the matrix. Lymphatic drainage and compression still continue as part of his regular treatment.

Complete closure by the 21st of April (photo taken on the 24th April).

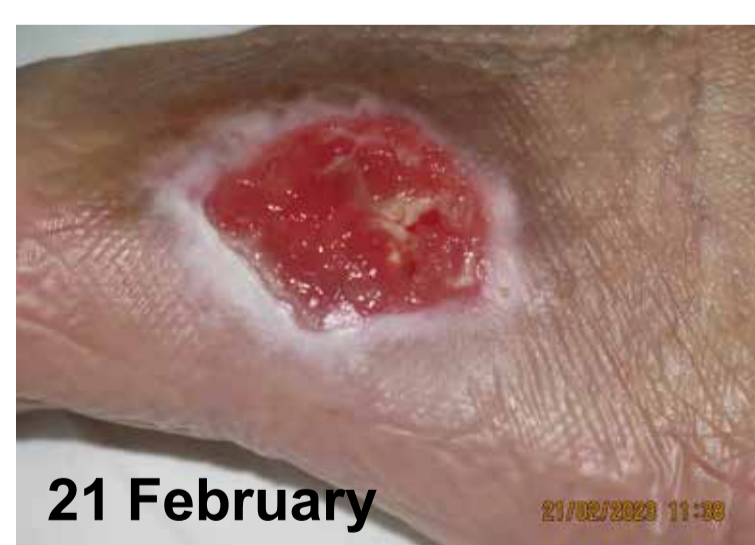
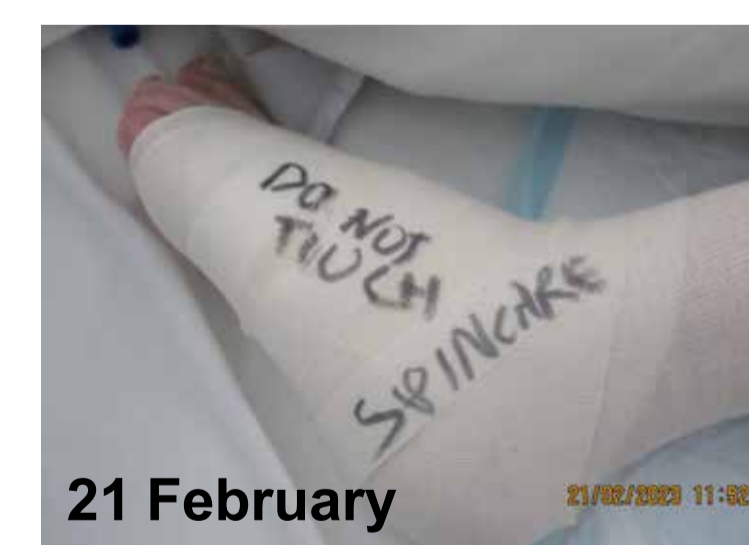
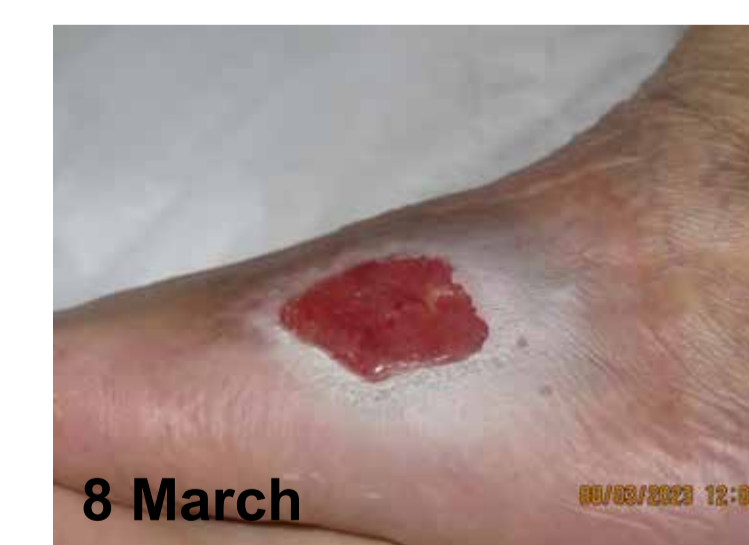
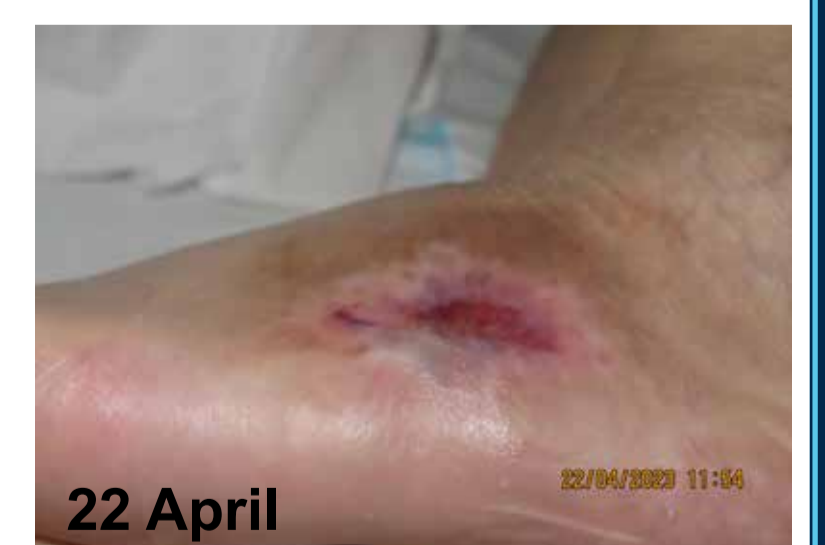
72-year-old male with uncontrolled diabetes and neuropathy developed a PU from using ill-fitting shoes. Various treatments were used, collagenase enzyme for debridement, Hyaluronic acid, hydrofibers and alginates. Duration of wound five months.

Eight weeks after we applied the first electrospun nanofibrous matrix on the the wound it had closed. A total of four applications were needed. A silicon based wound contact layer and non-woven gauze was used on top of the matrix. Since the wound was relatively dry it would have been enough to change the secondary dressings once a week. Due to the insecurity of the patient and his nurses they opted to change every other day. Our impression was that this scaffold matrix help to provide the environment for the wound to turn from chronic characteristic to an acute one towards completion of the healing process.
